AFWAL-TM-79-10

**TEST REPORT ON INFRARED
WARNING RECEIVER (IRWR) FLIGHT
VIBRATION MEASUREMENTS**

APRIL 1980

This test report presents data which define the vibration environments experienced by two infrared warning receiver (IRWR) units mounted on the HH-53 helicopter and the C-130E transport aircraft.

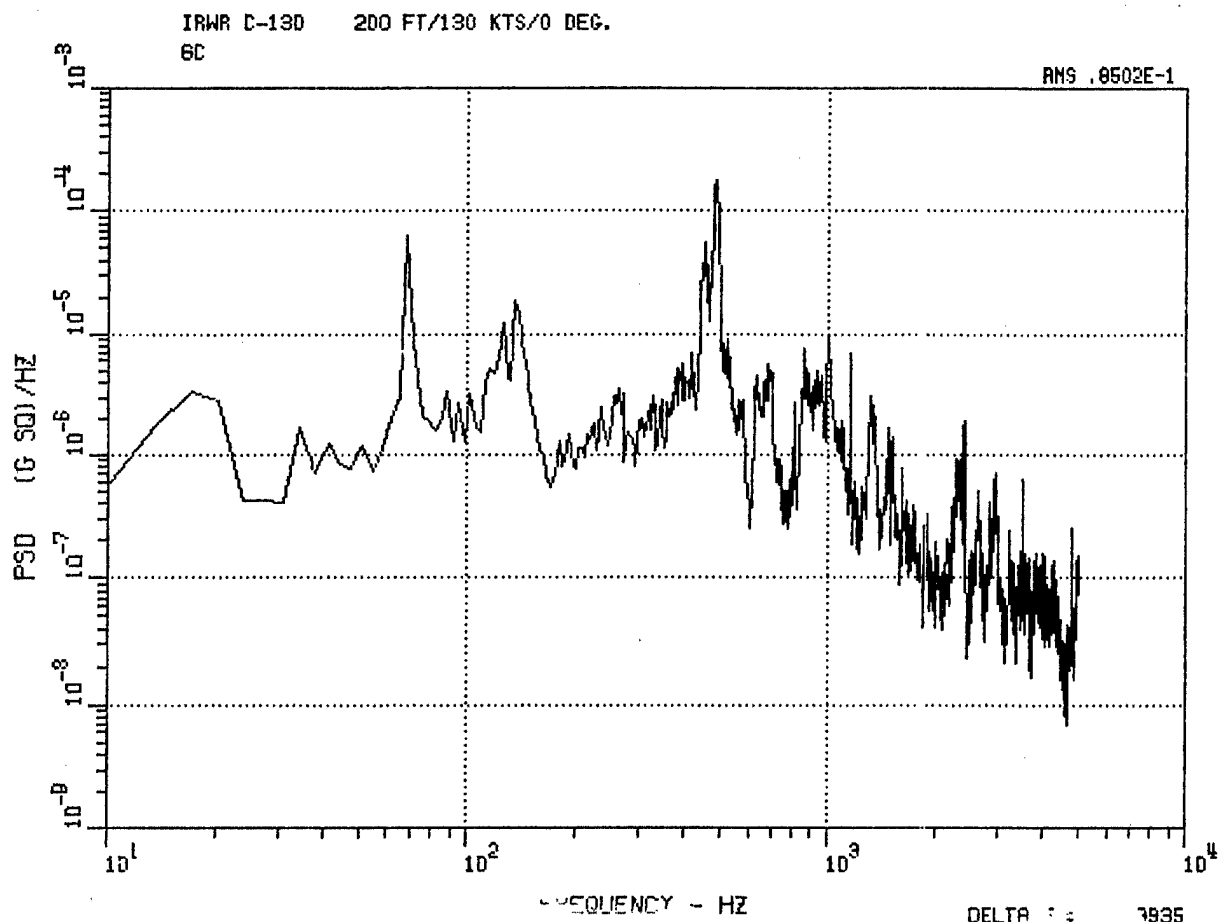
Figure 36. C-130 Center Longitudinal Accelerometer 6C,
200 Ft, 130 Kt, 0 Deg, and 1000 Ft, 130 Kt,
0 Deg.

The AAR-44 environments on the C-130 are shown in Figures 28-43. The vertical acceleration PSDs for Sensor 1C are shown in Figures 28-41, the lateral PSDs (Sensor 3C) in Figures 32-35, and the longitudinal PSDs (Sensor 6C) in Figures 36-39. The spectra are all distinctly lower in overall rms response than the forward AAR-43 location. The acoustic noise levels, shown in Figures 41-43, are about 16 dB higher than the forward location at 130 knots airspeed and are about 11 dB higher at 250 kts. At the higher flight speeds the noise levels are 139-140 dB, which may cause some difficulty for sensitive electronics.

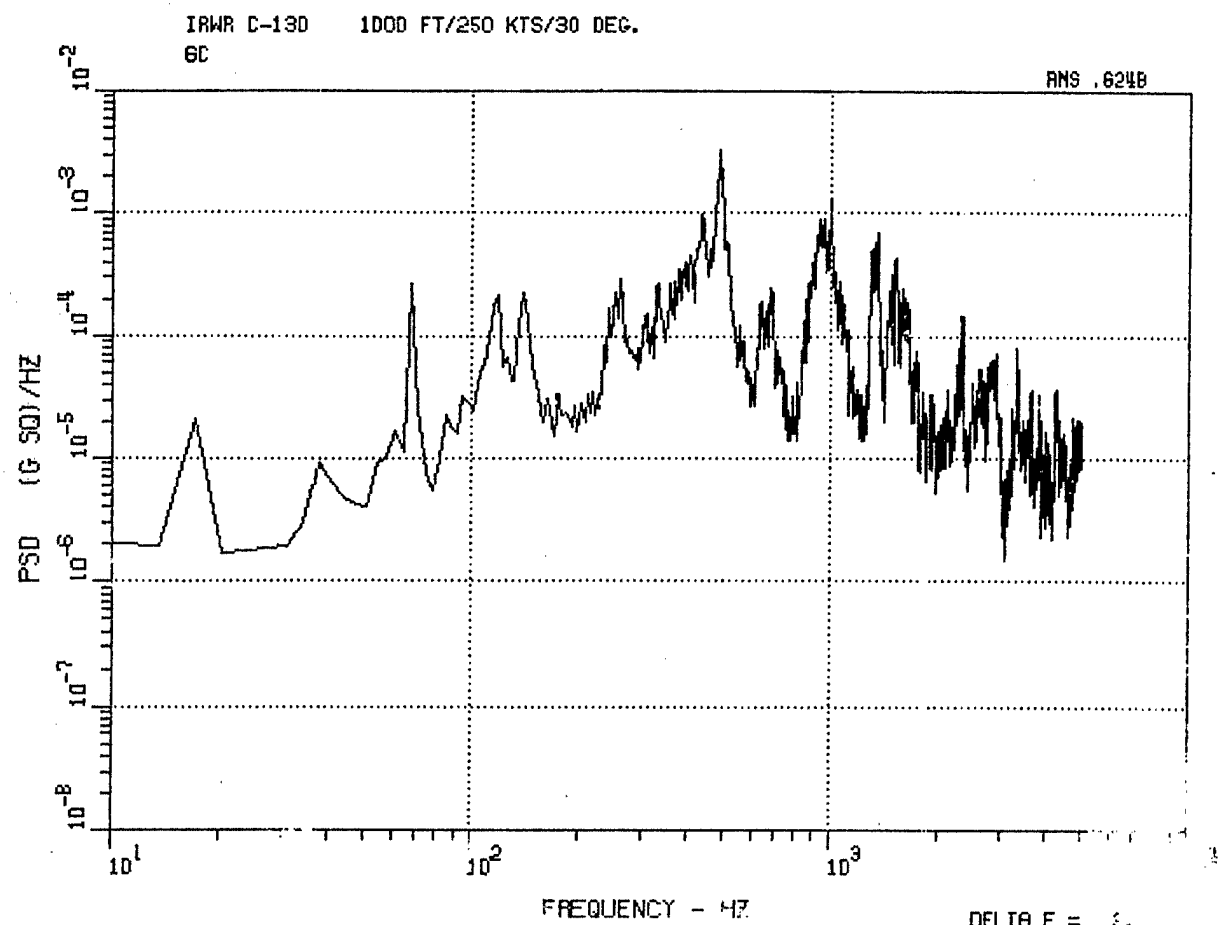
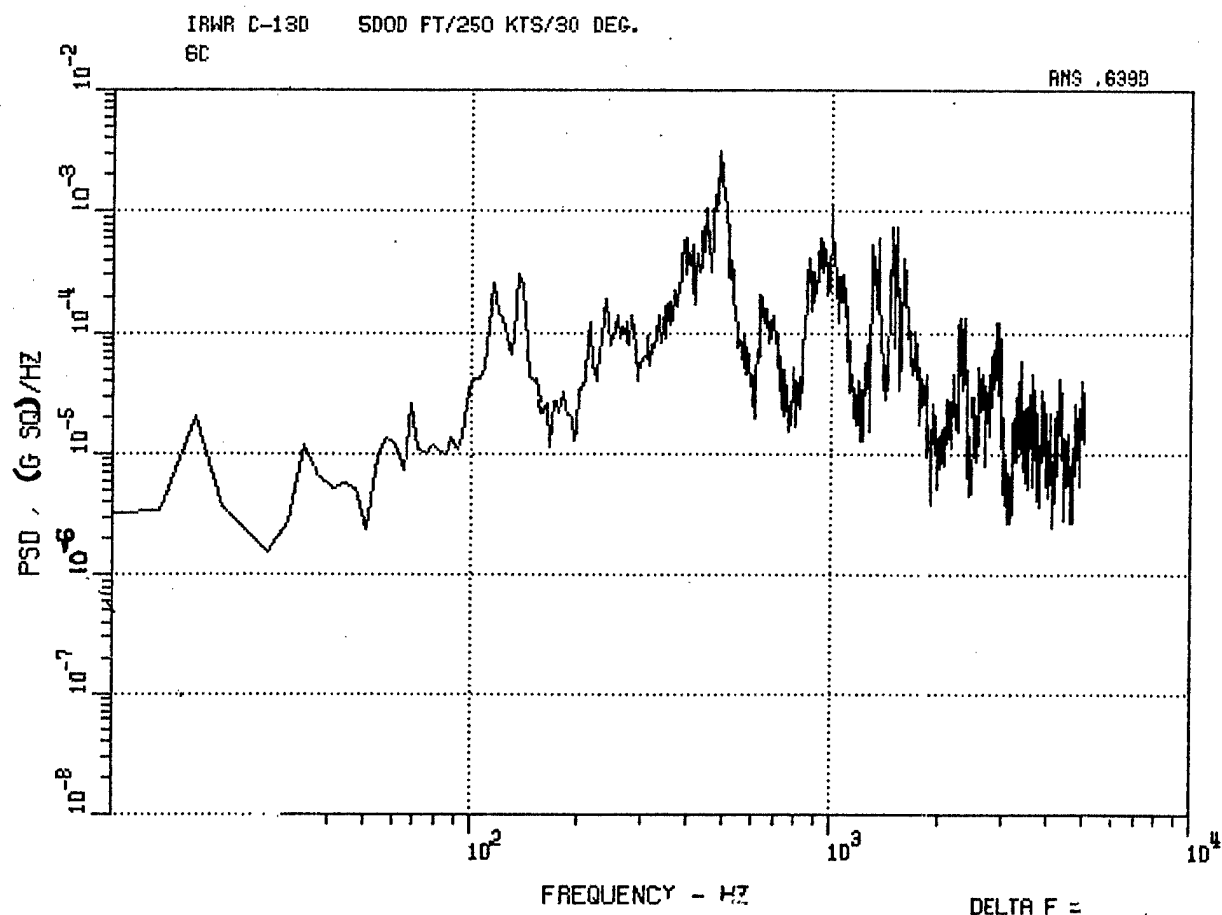
Figure 38. C-130 Center Longitudinal Accelerometer 6C,
1000 Ft, 250 Kt, 30 Deg, and 5000 Ft, 250 Kt,
30 Deg.

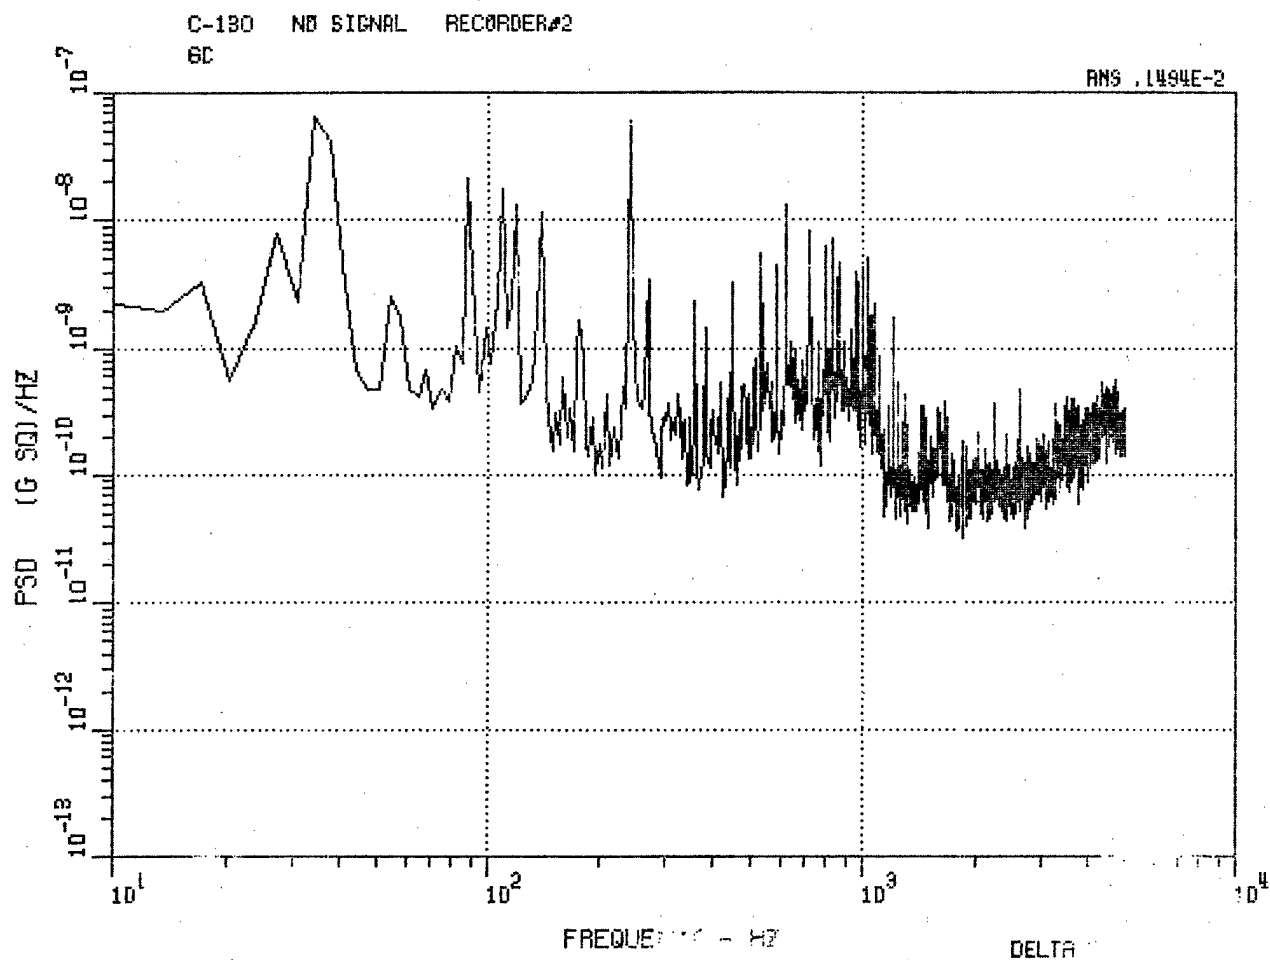
Figure 39. C-130 Center Longitudinal Accelerometer 6C,
No-Signal Record.

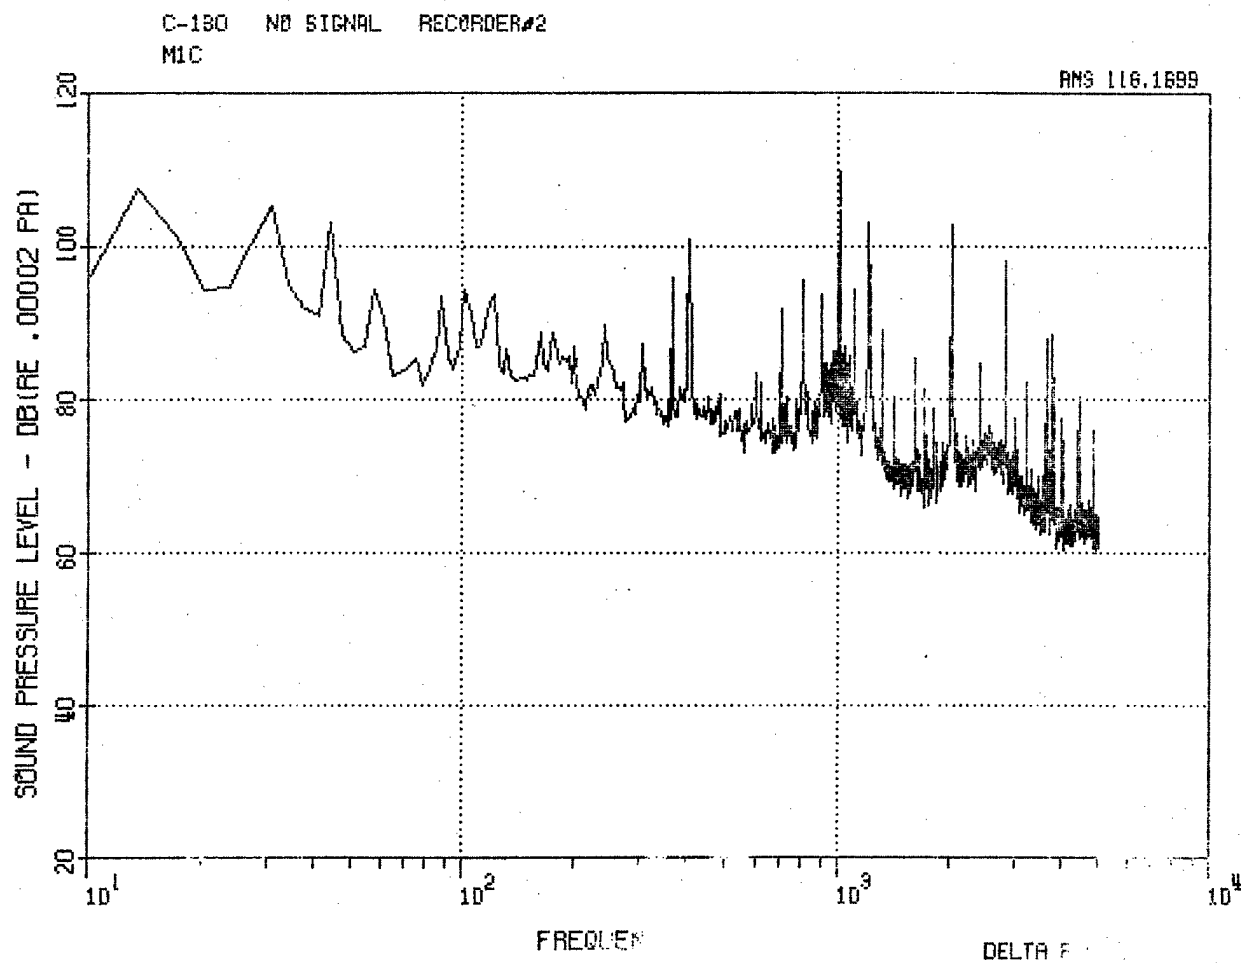
Figure 43. C-130 Center Microphone MC, No-Signal Record.

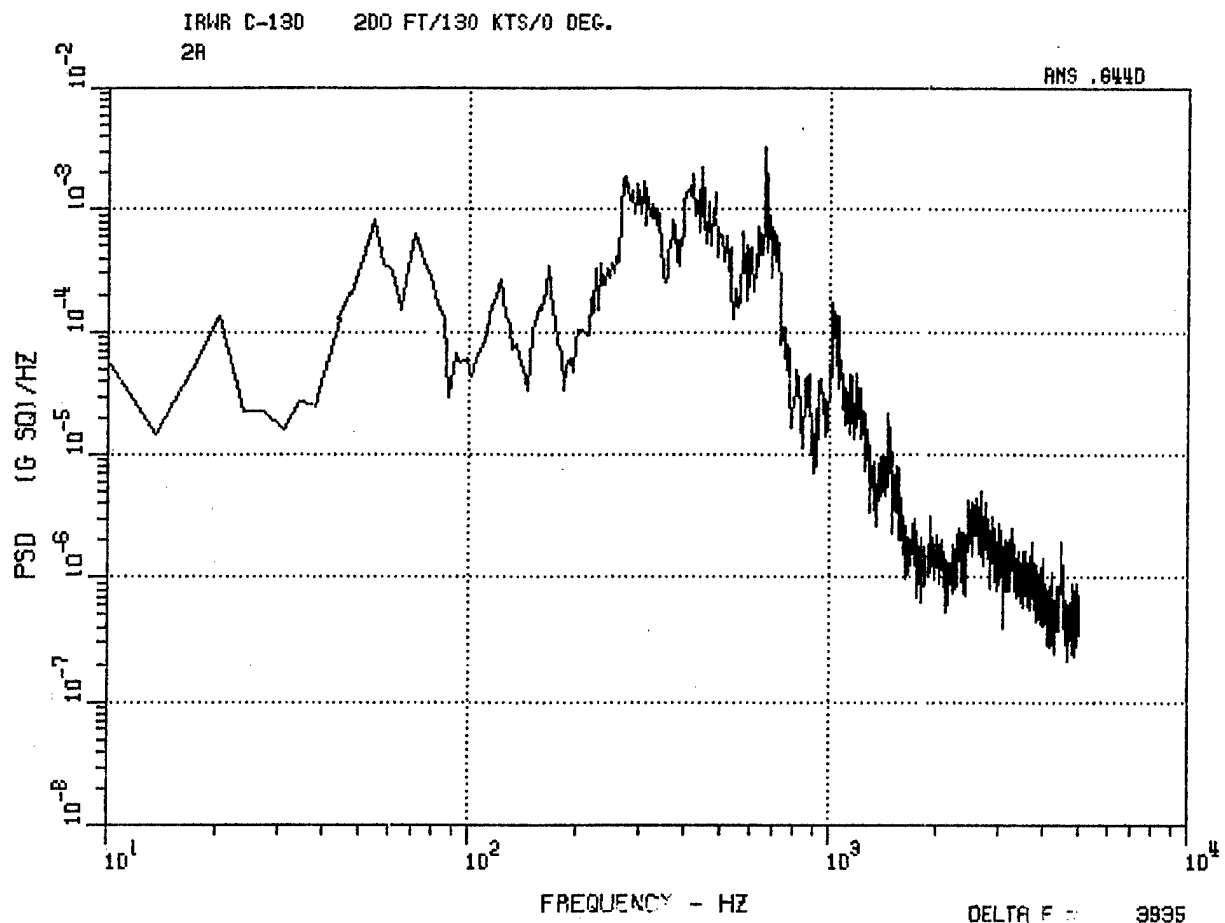
Figure 44. C-130 Aft Lateral Accelerometer 2A, 200 Ft, 130 Kt, 0 Deg, and 1000 Ft, 130 Kt, 0 Deg.

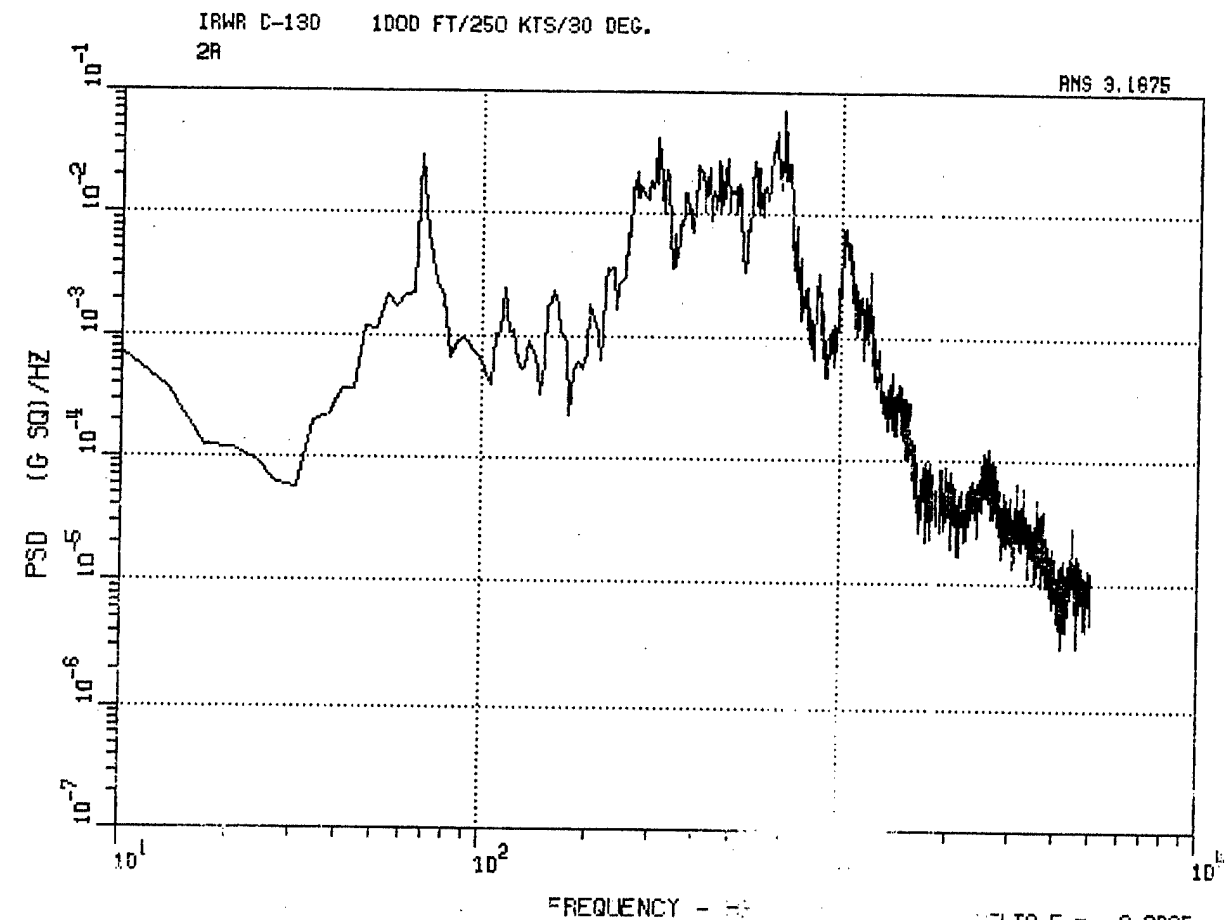
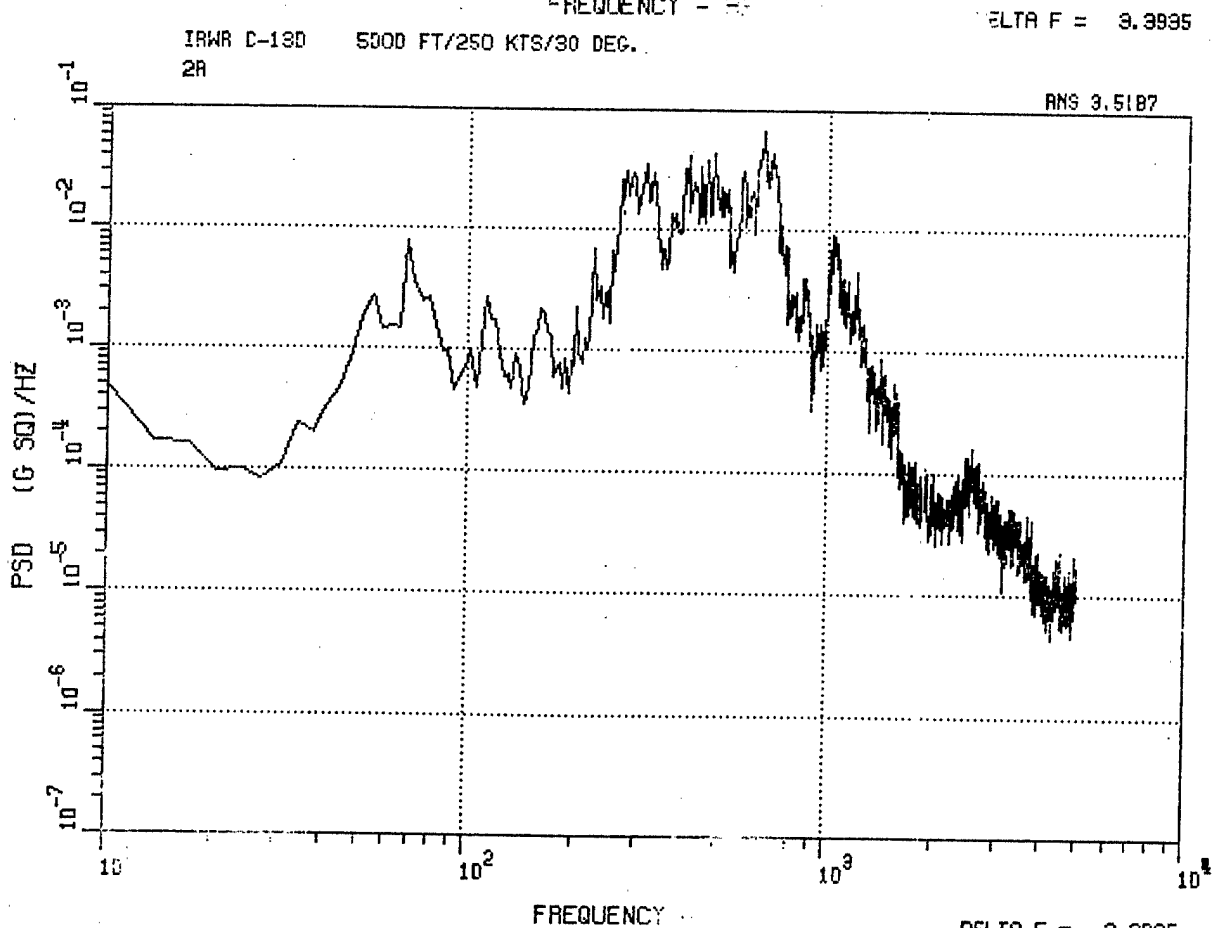
Figure 46. C-130 Aft Lateral Accelerometer 2A, 1000 Ft, 250 Kt, 30 Deg, and 5000 Ft, 250 Kt, 30 Deg.

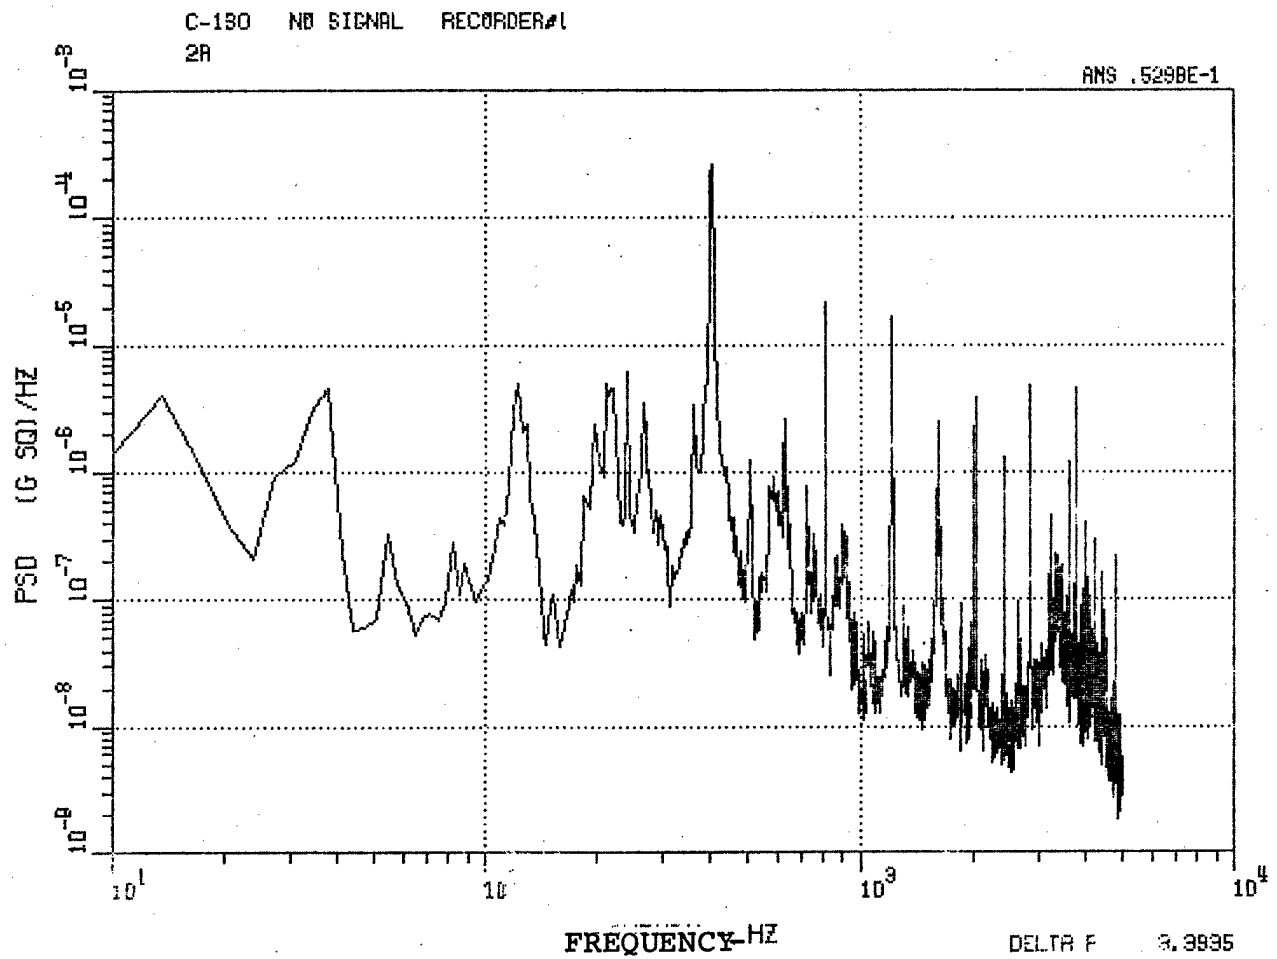
Figure 47. C-130 Aft Lateral Accelerometer 2A,
No-Signal Record.

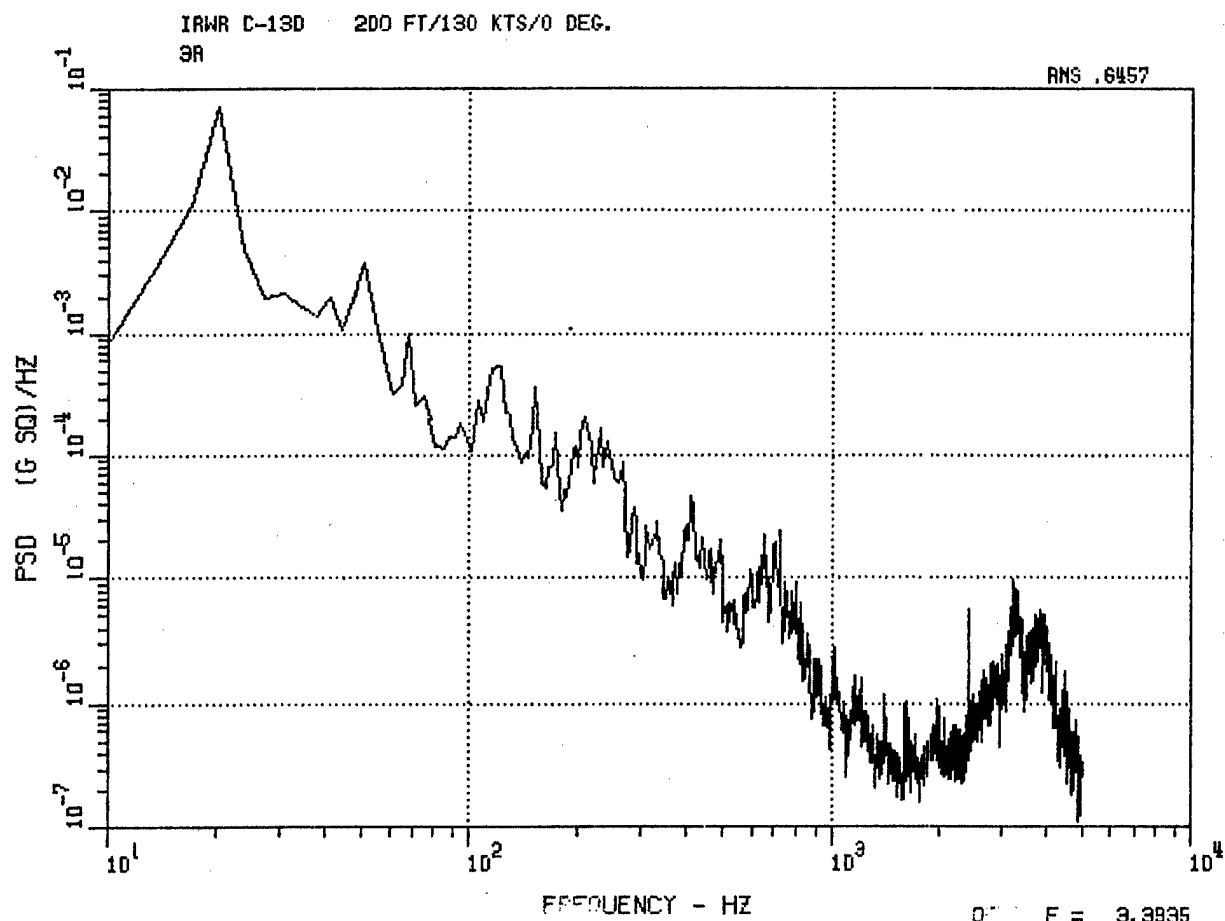
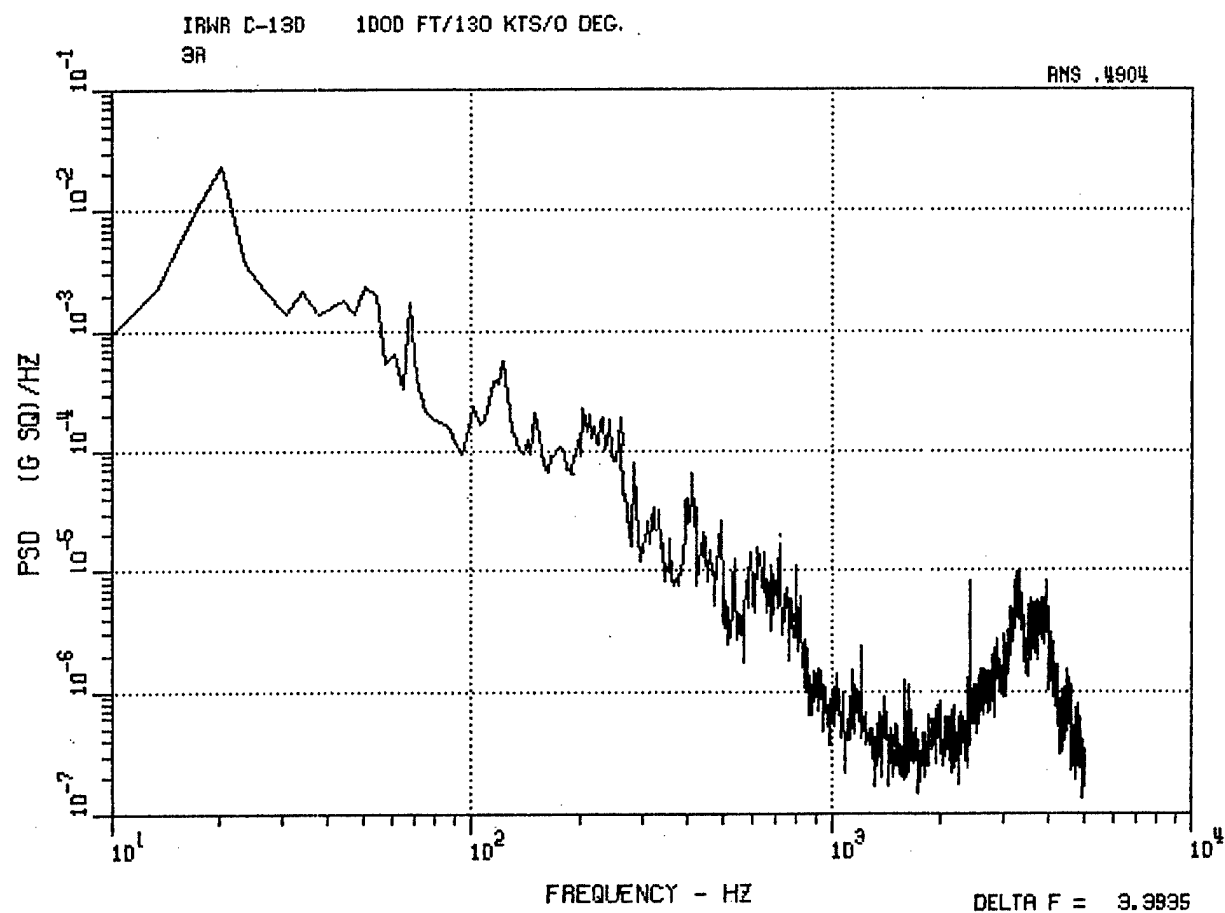
Figure 48. C-130 Aft Vertical Accelerometer 3A, 200 Ft, 130 Kt, 0 Deg, and 1000 Ft, 130 Kt, 0 Deg.

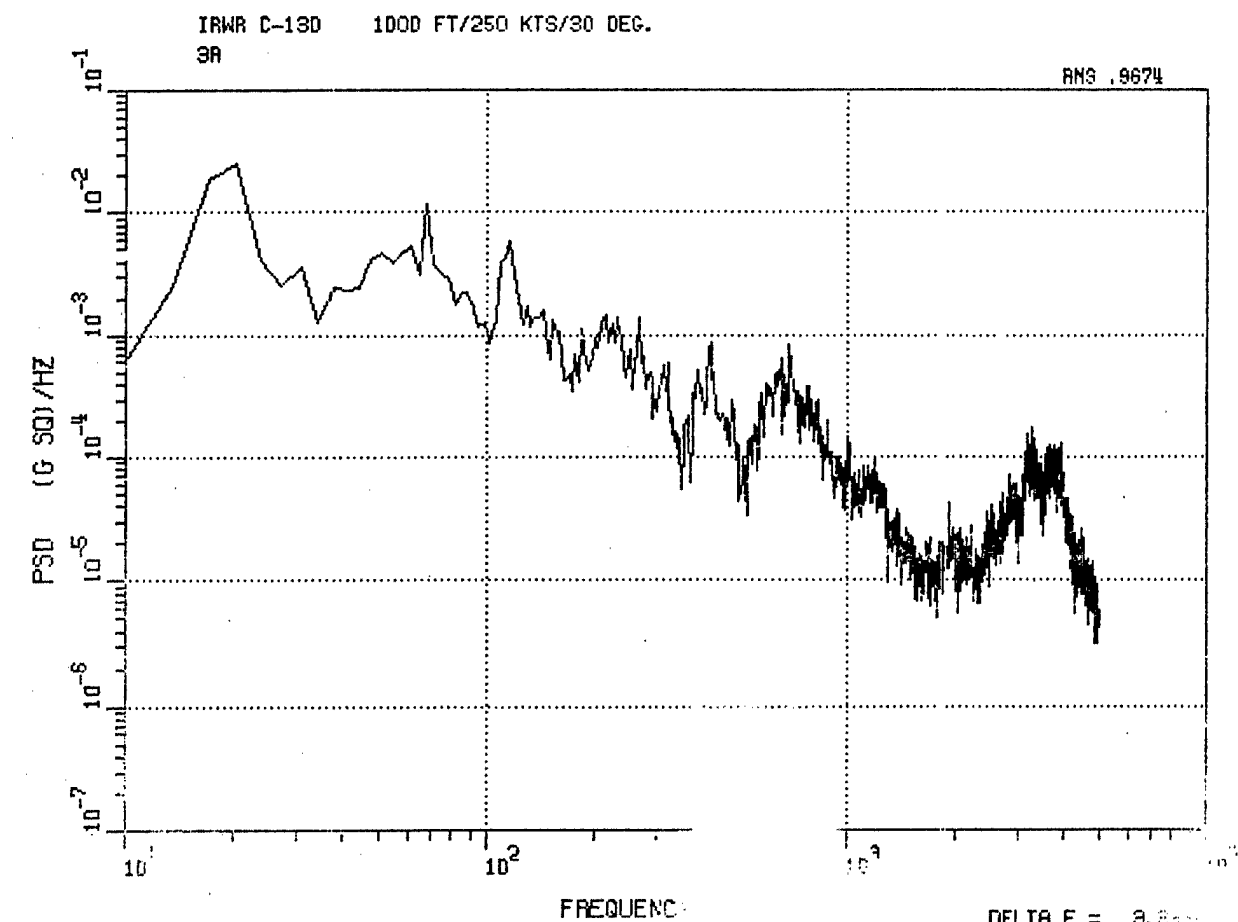
Figure 50. C-130 Aft Vertical Accelerometer 3A, 1000 Ft, 250 Kt, 30 Deg, and 5000 Ft, 250 Kt, 30 Deg.

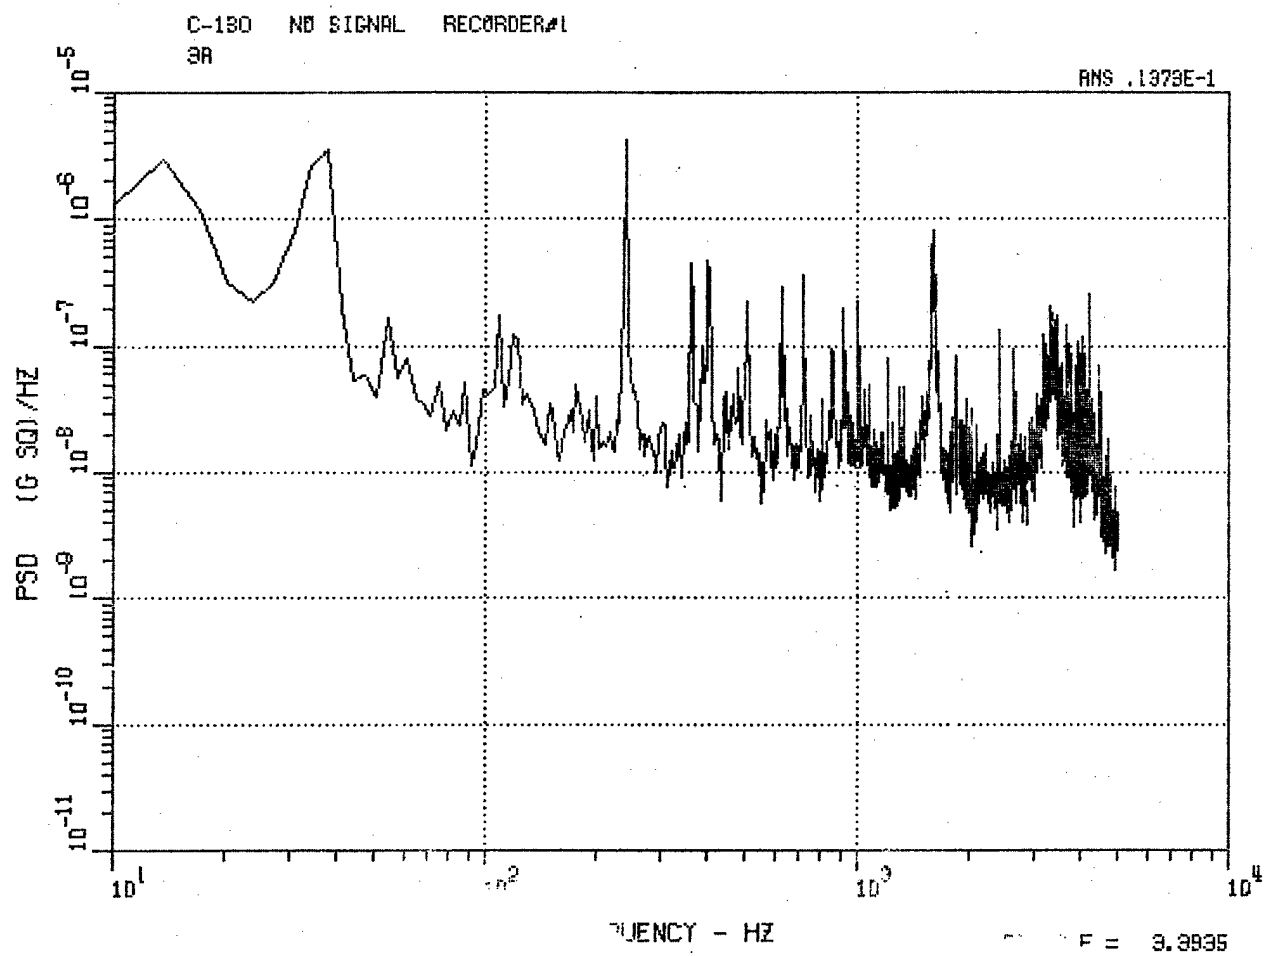
Figure 51. C-130 Aft Vertical Accelerometer 3A,
No-Signal Record.

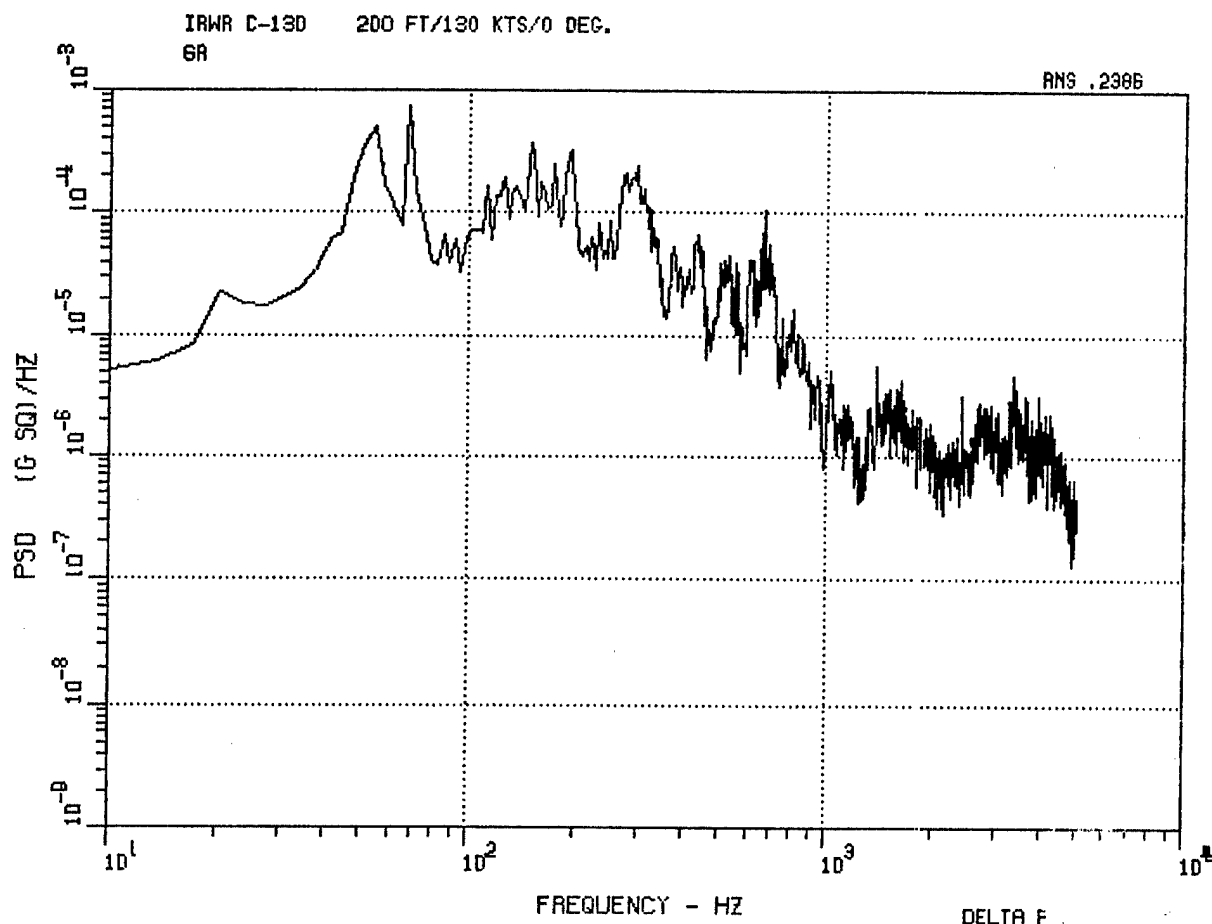
Figure 52. C-130 Aft Longitudinal Accelerometer 6A,
200 Ft, 130 Kt, 0 Deg, and 1000 Ft, 130 Kt,
0 Deg.

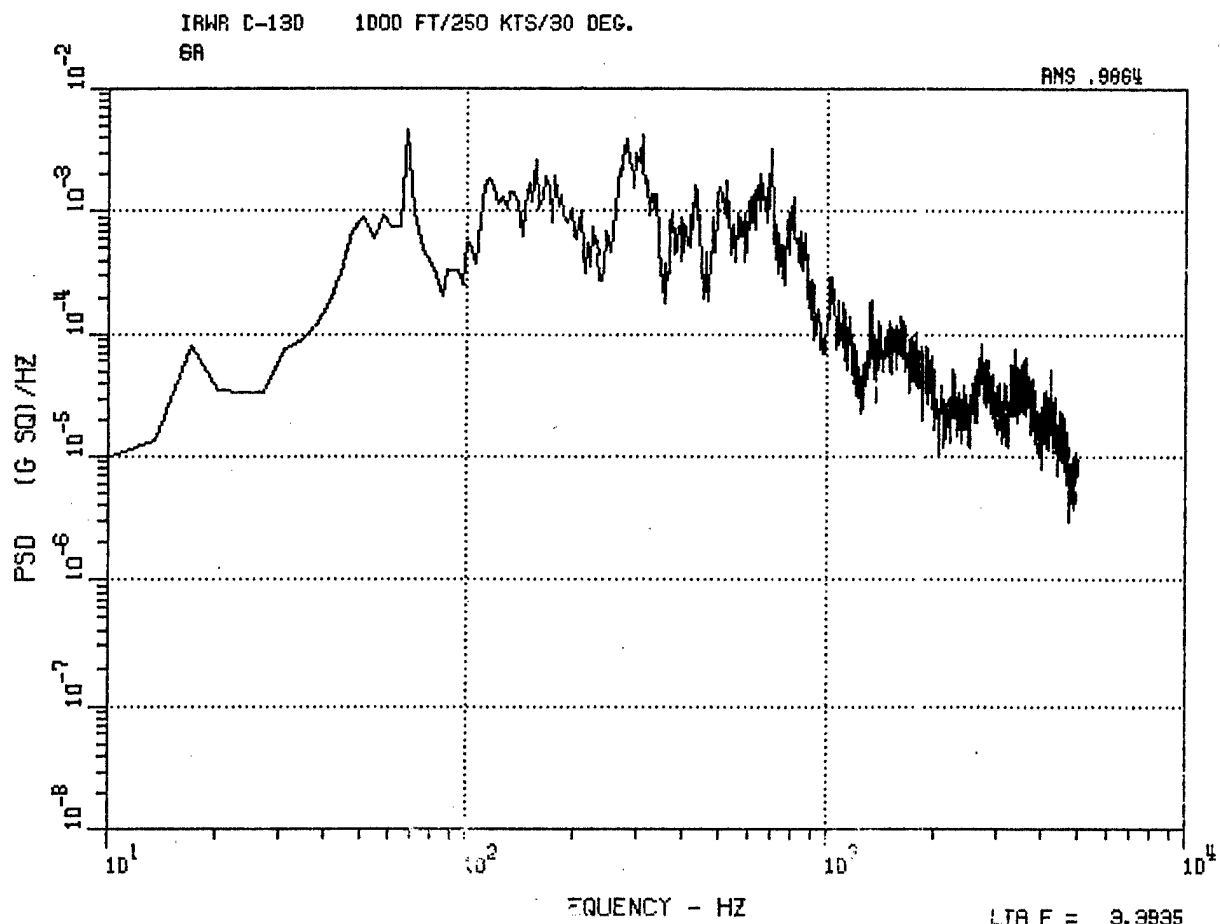
Figure 54. C-130 Aft Longitudinal Accelerometer 6A,
1000 Ft, 250 Kt, 30 Deg, and 5000 Ft, 250 Kt,
30 Deg.

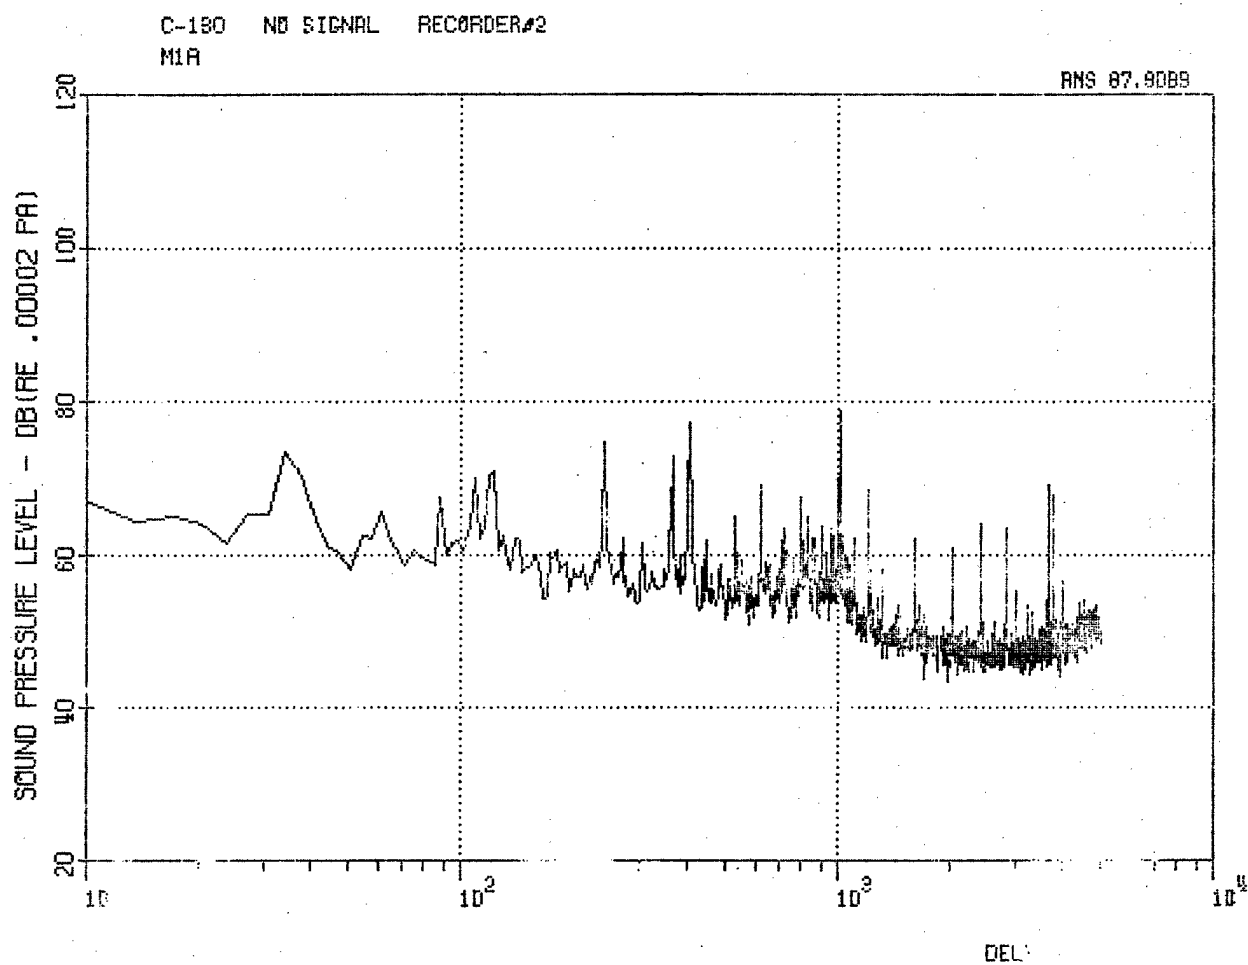
Figure 59. C-130 Aft Microphone MA, No-Signal Record.

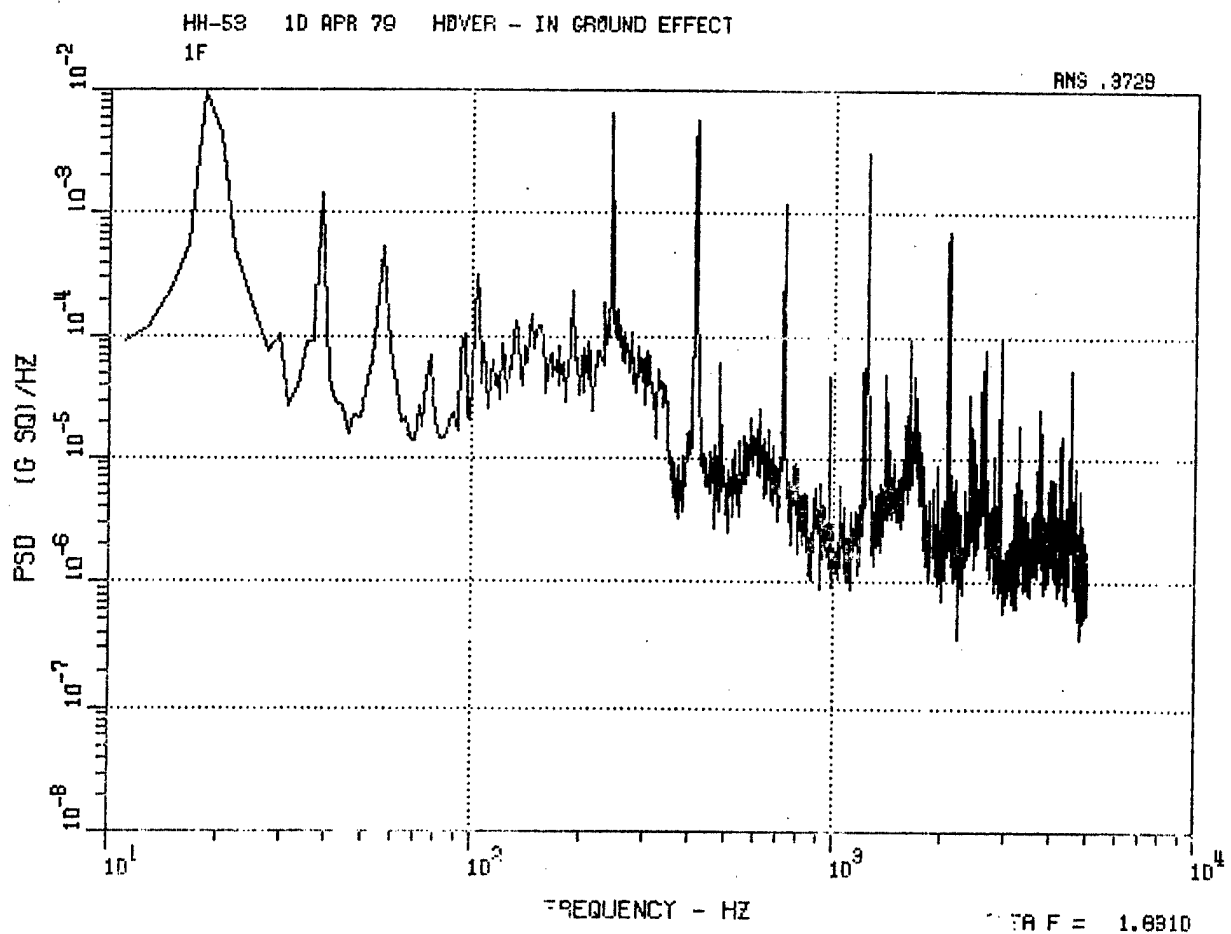
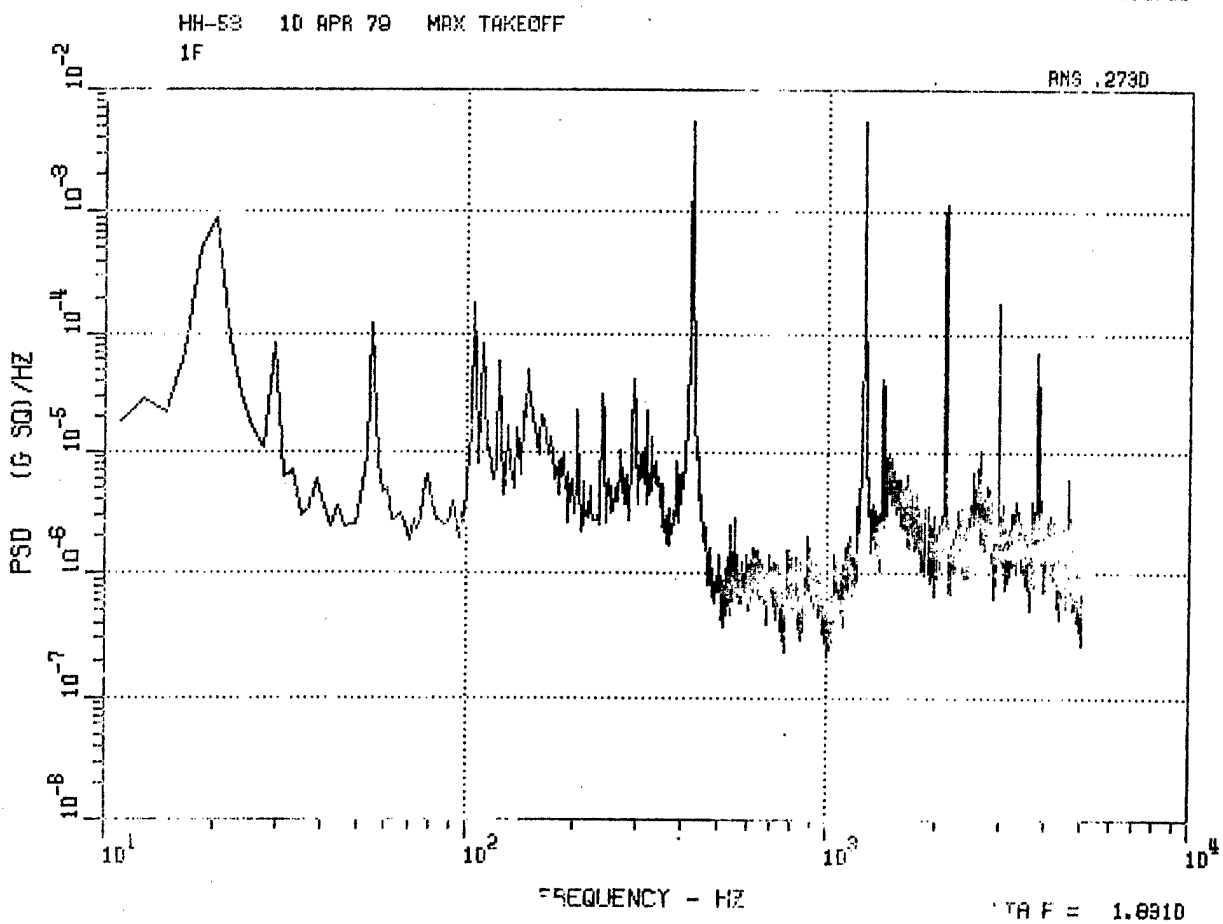
Figure 60. HH-53 Fwd Lateral Accelerometer 1F,
Hover IGE and Max Takeoff.

The HH-53 spectra are shown in Figures 60-95 for five flight conditions and for the no-signal condition. The lateral vibration at the forward AAR-43 location is shown for Sensor 1F in Figures 60-62. The responses are less than 0.5g rms and are dominated by the rotor blade passage frequencies and by the narrowband engine frequencies. The vertical accelerations, shown for Sensor 4F in Figures 63-65, are no more than 0.25g rms and the spectra show a gradual decrease at frequencies from 100 Hz to 1000 Hz. The longitudinal accelerations, represented by Sensor 6F in Figures 66-68, are also very low, reaching less than 0.3g. The noise responses from microphone MF, shown in Figures 69-71, are a moderate 122-130 dB. The greatest response is at the 18-Hz rotor slapping frequency.

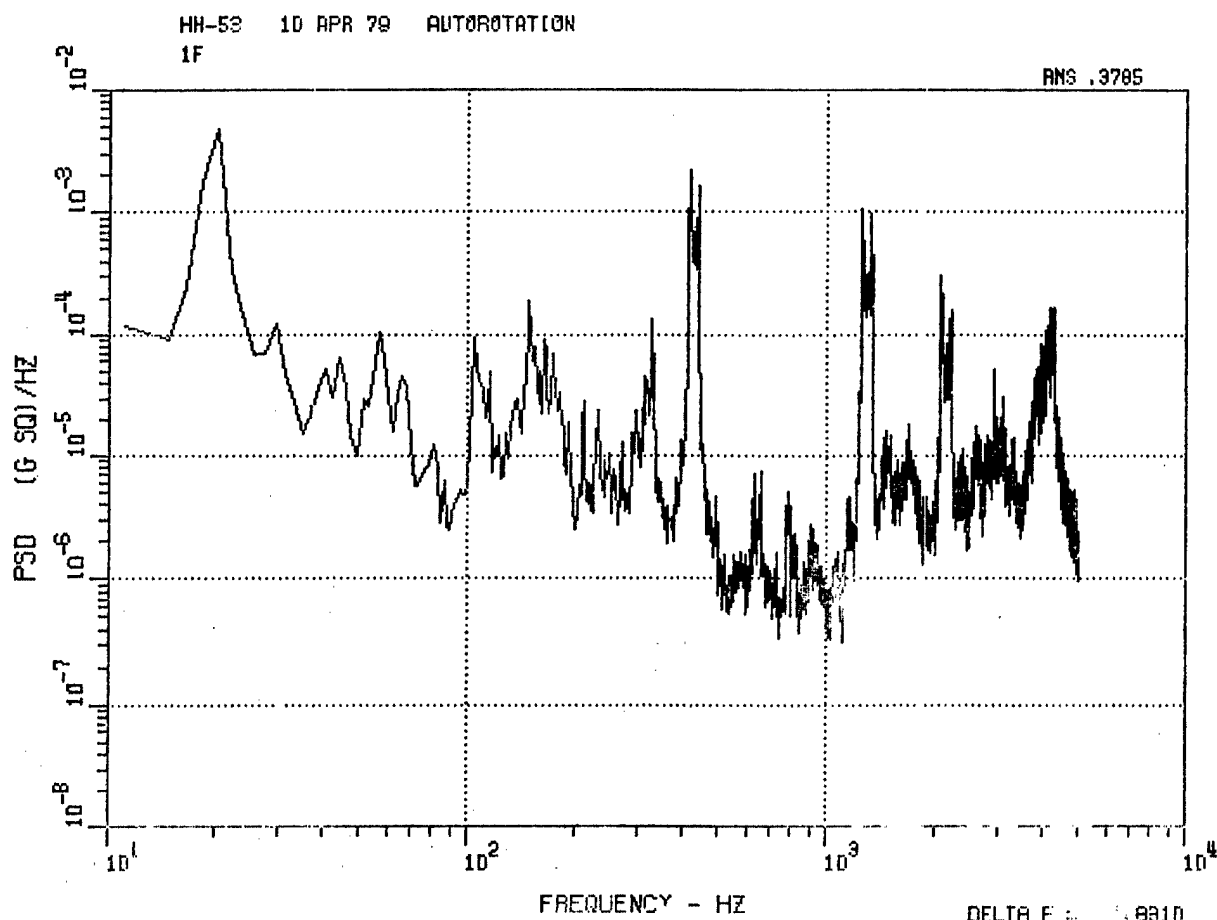
Figure 62. HH-53 Fwd Lateral Accelerometer 1F, Autorotation and No-Signal Record.
